HARFORD COUNTY DPW

UPPER FARNANDIS SMALL WATERSHED ASSESSMENT REPORT

APRIL 02, 2018

HARFORD COUNTY DEPARTMENT OF
PUBLIC WORKS

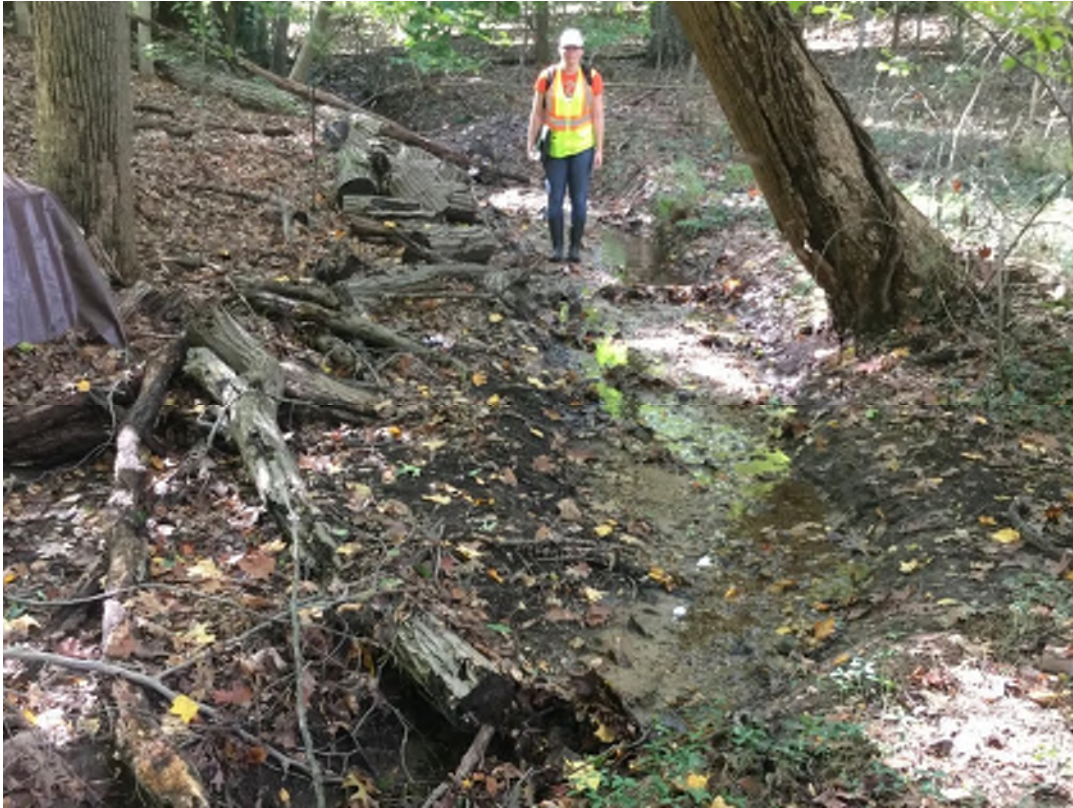
Figure 23: Subsurface flow begins in tributary 3 prior to confluence with mainstem.

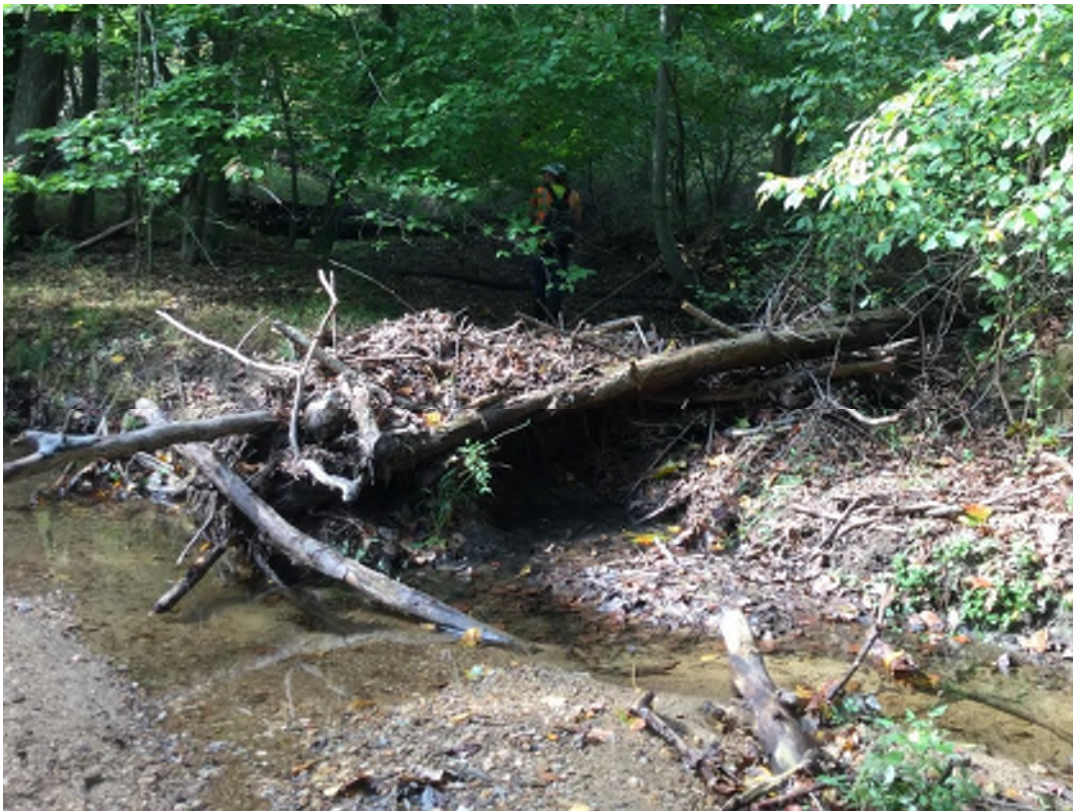
Figure 24: Debris jam at confluence of tributary 3 (right) with mainstem (left).

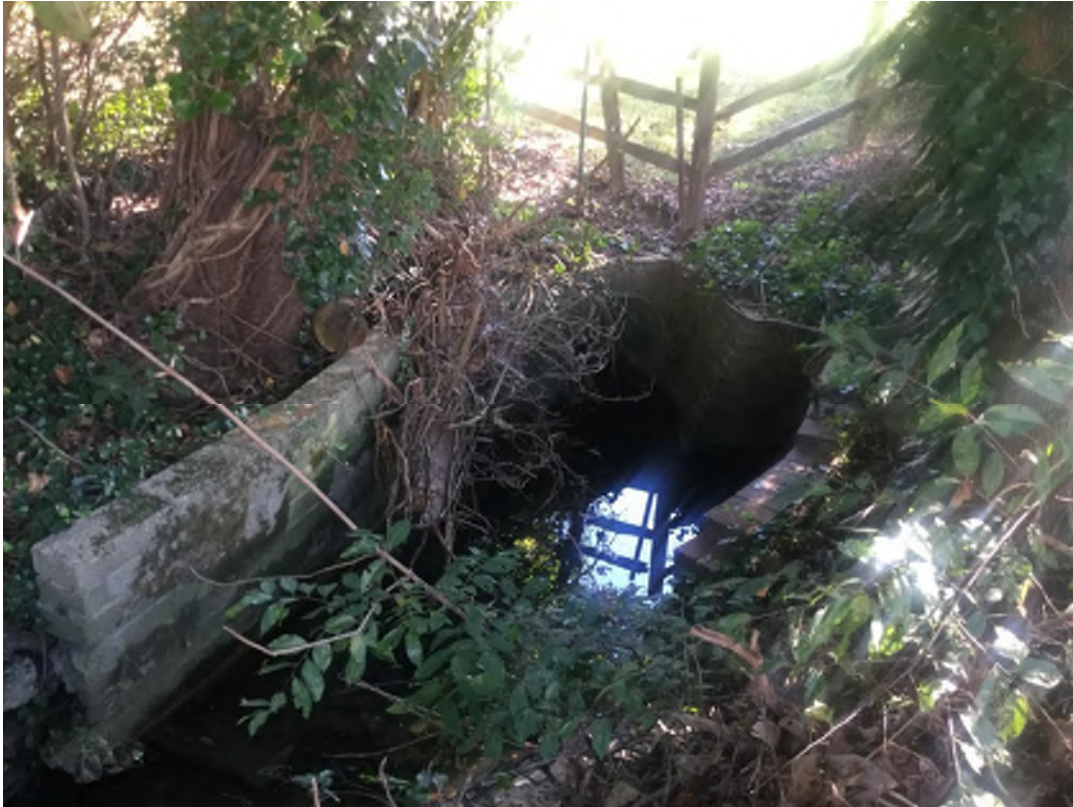
Figure 1: Outfall 34 (pictured on right) and outfall 35 (left) convey inflow to headwaters of mainstem. Outfall 34 is a 24-inch concrete pipe. Outfall 35 is a 30-inch concrete pipe. Standing water present at outfalls. Brick and concrete structure surrounding outfalls.

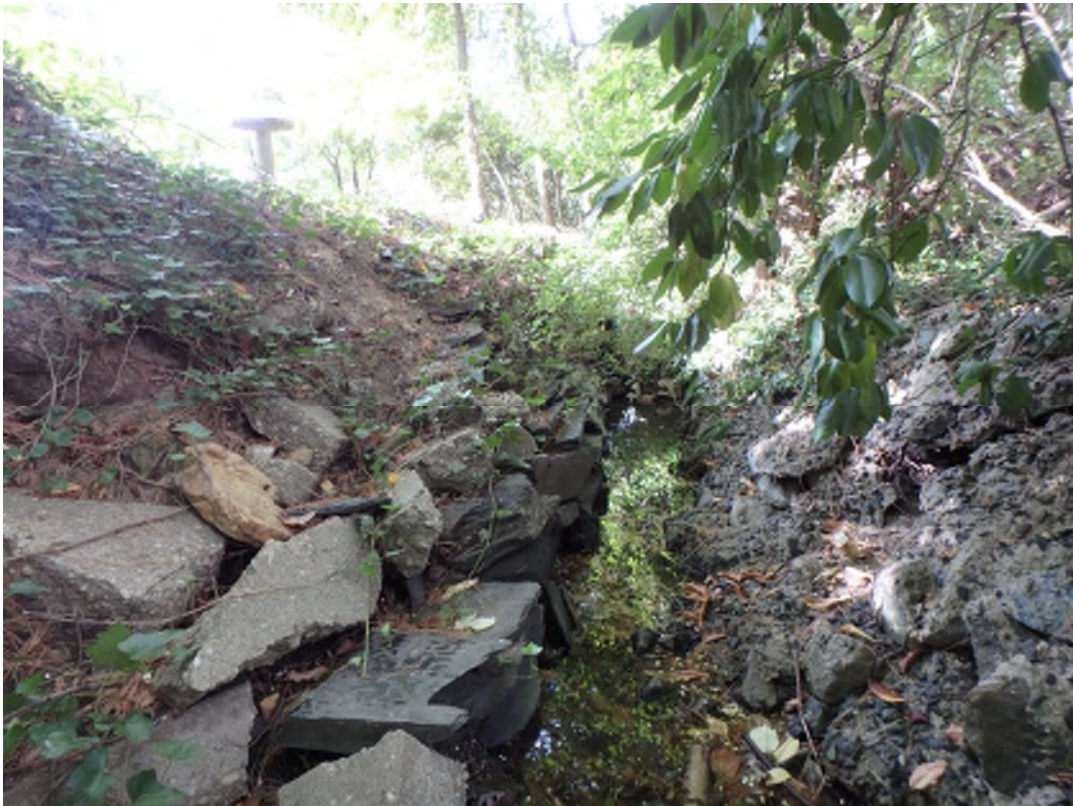
Figure 2: Concrete and riprap channel alteration immediately downstream of outfall 34 and outfall 35 in mainstem.

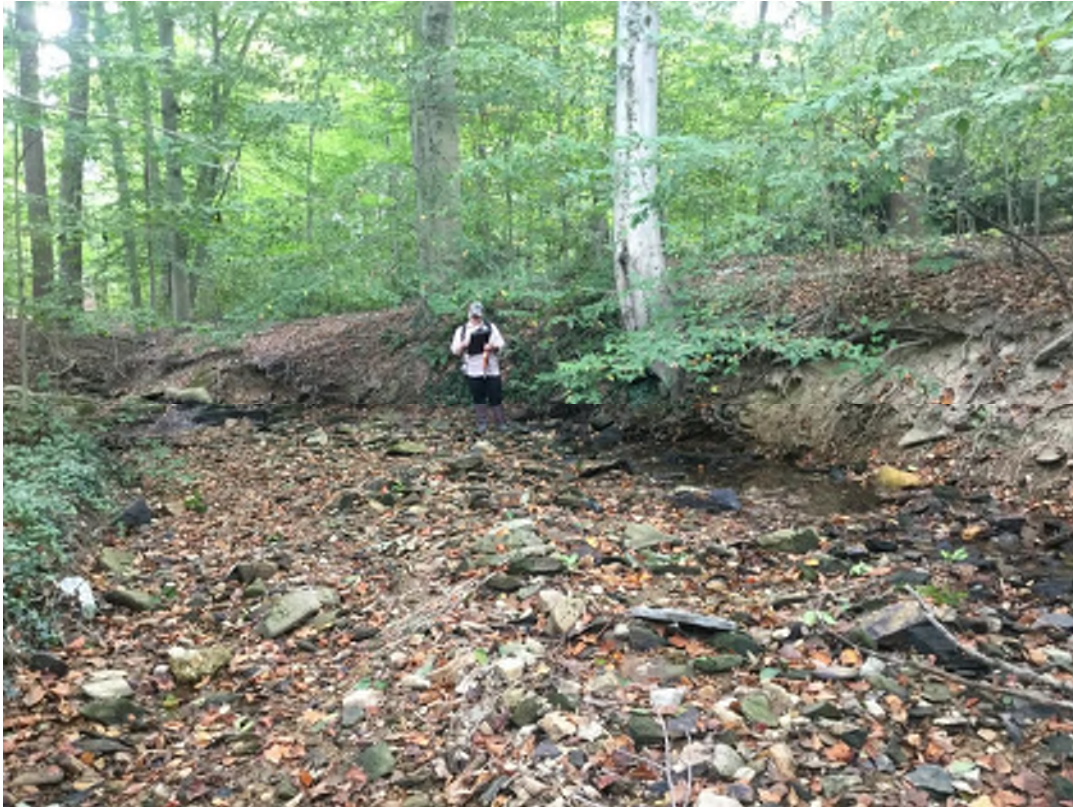
Figure 5: Bank erosion in mainstem.

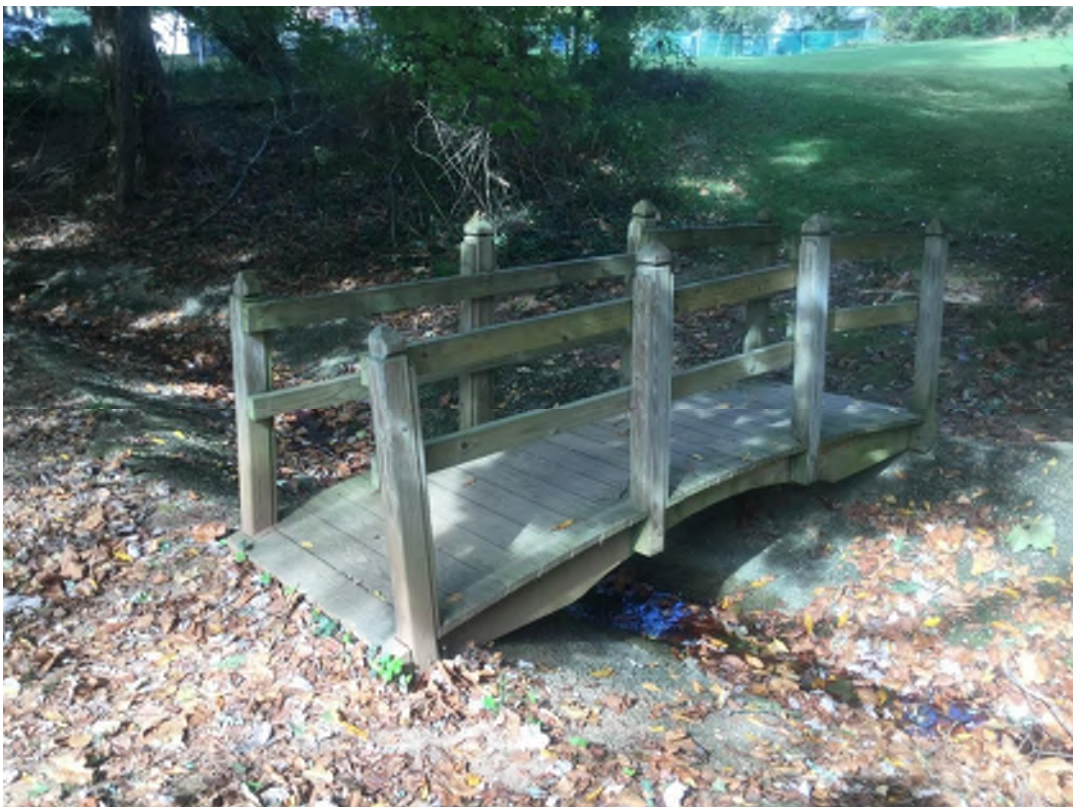
Figure 6: Footbridge at downstream end of concrete channel alteration (Figure 4).

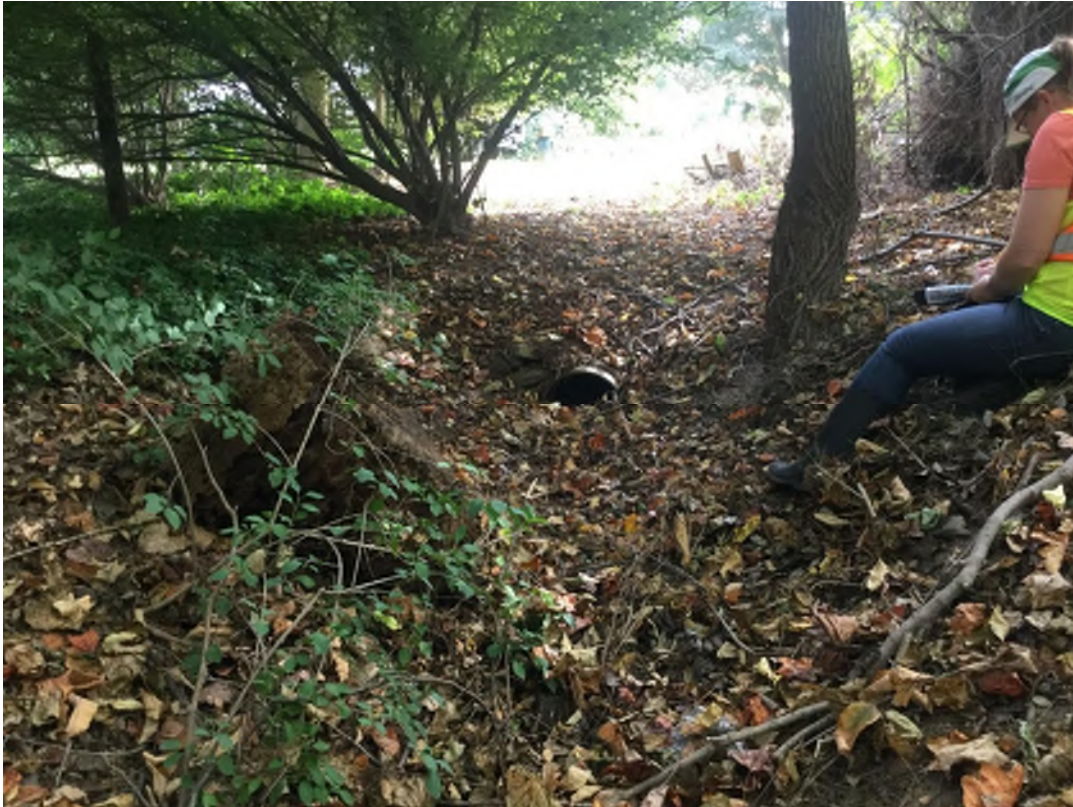
Figure 7: Outfall 33 is an 18-inch concrete pipe that conveys flow to the right bank of the mainstem. Outfall is approximately 150 feet from stream.

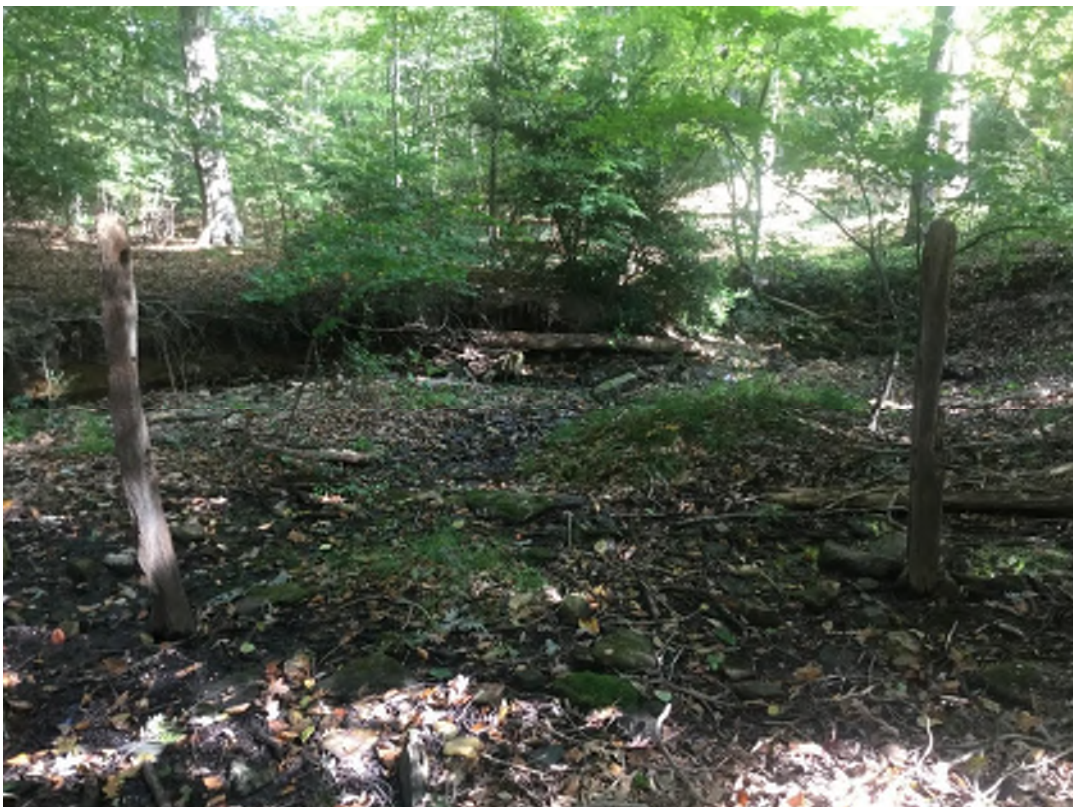
Figure 8: Natural spring starting location and channel leading to right bank of mainstem.

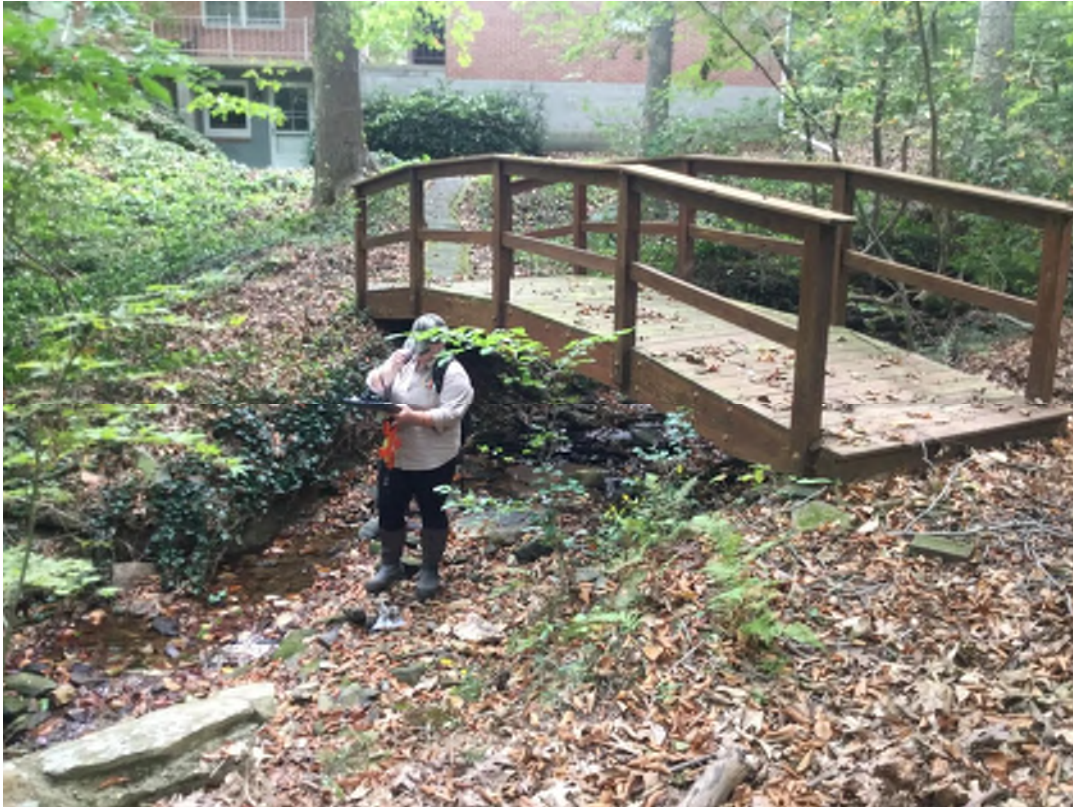
Figure 9: Wooden pedestrian bridge on mainstem prior to confluence with tributary 1.

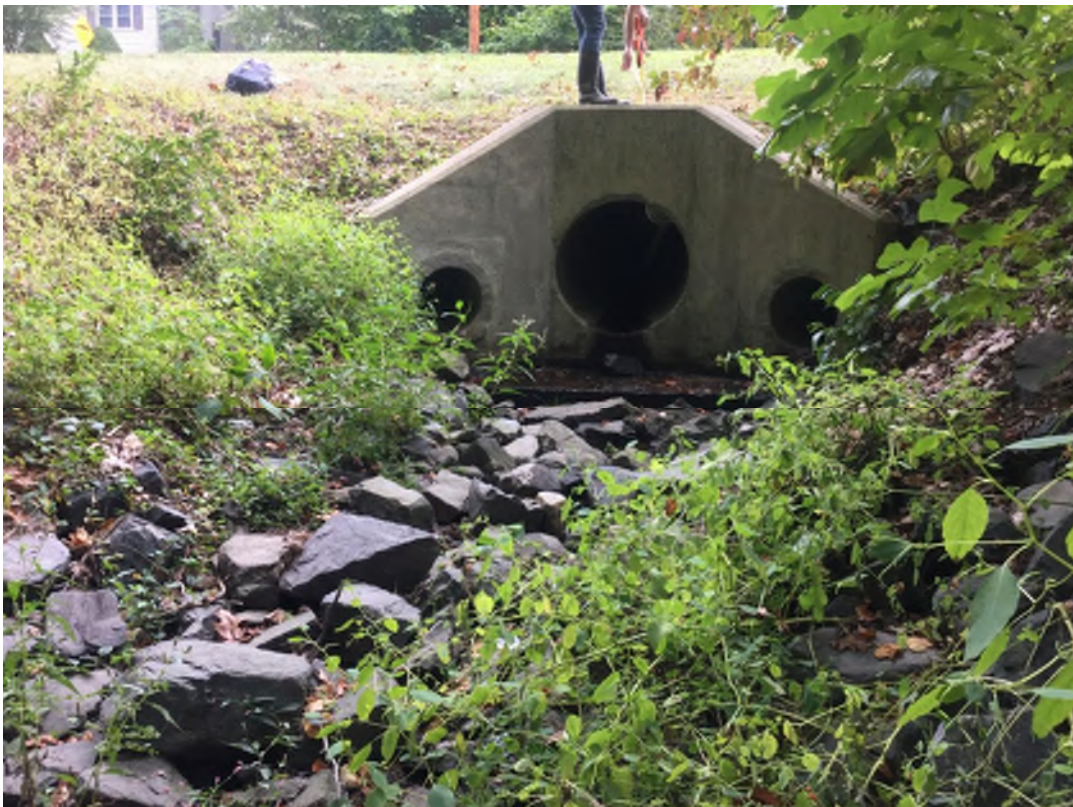
Figure 10: Outfall 28 is an 18-inch concrete pipe at the headwaters of tributary 1. Outfall is approximately 62 feet from the stream. Tributary 1 enters mainstem on right bank.

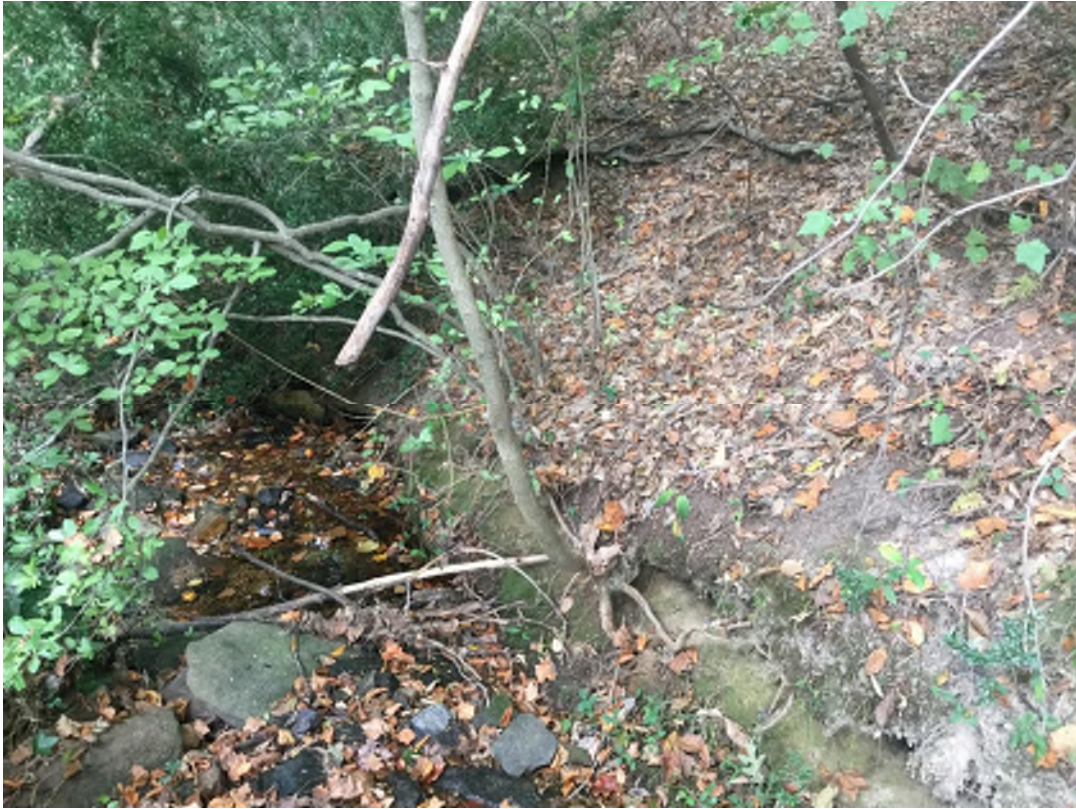
Figure 11: Bank erosion in tributary 1.

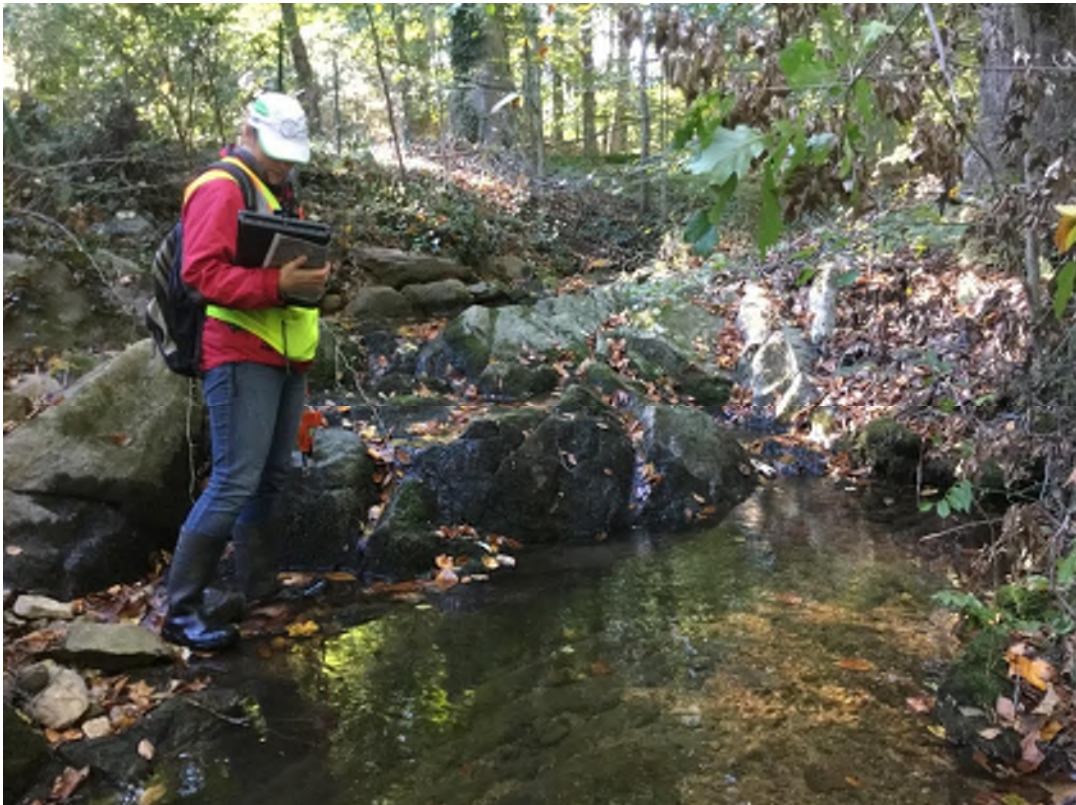
Figure 12: Fish barrier in mainstem upstream of outfall 41. Natural falls barrier with too high jump for fish passage.

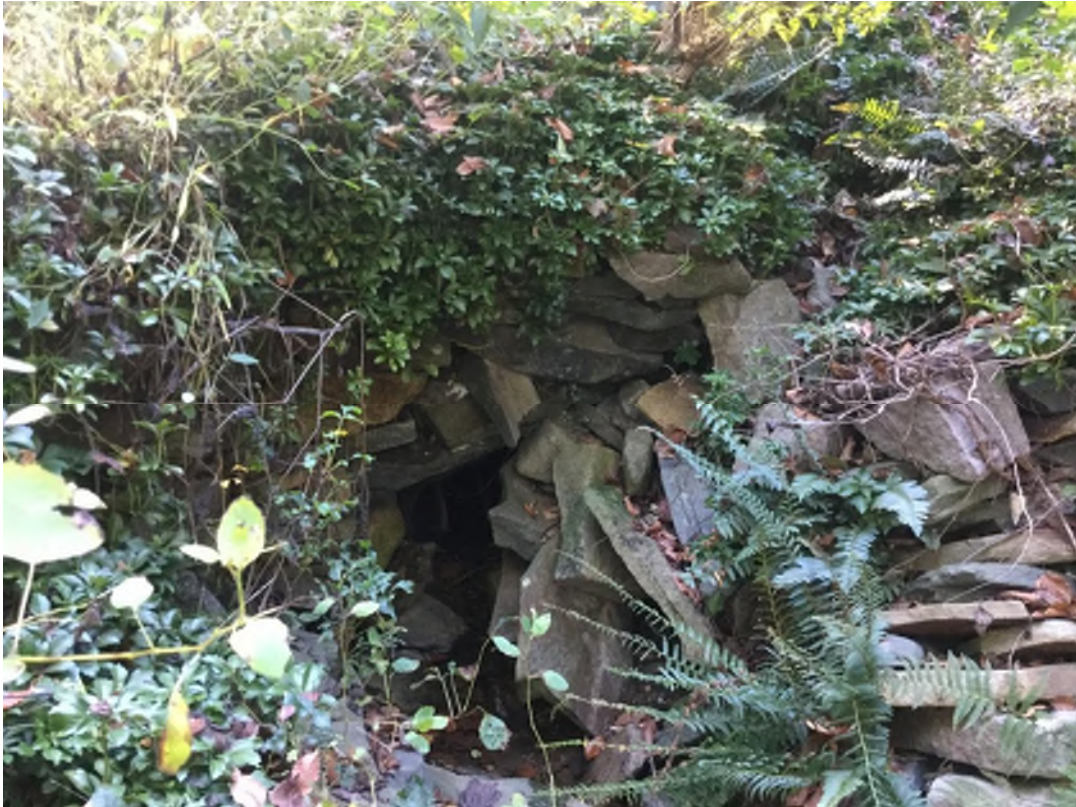
Figure 13: Outfall 41 is a 15-inch metal pipe conveying flow to the right bank of the mainstem. Outfall is approximately 89 feet from stream and has approximately 4 feet of riprap outfall protection.

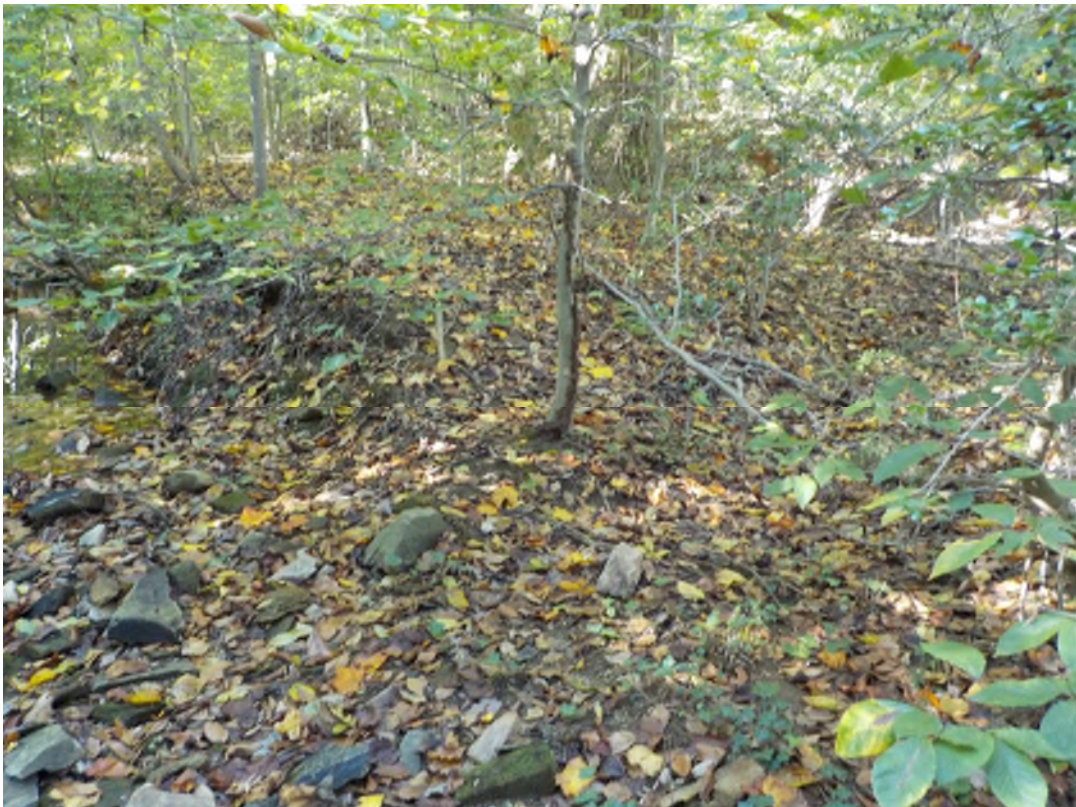
Figure 14: Dry basin outfall to left bank of mainstem.

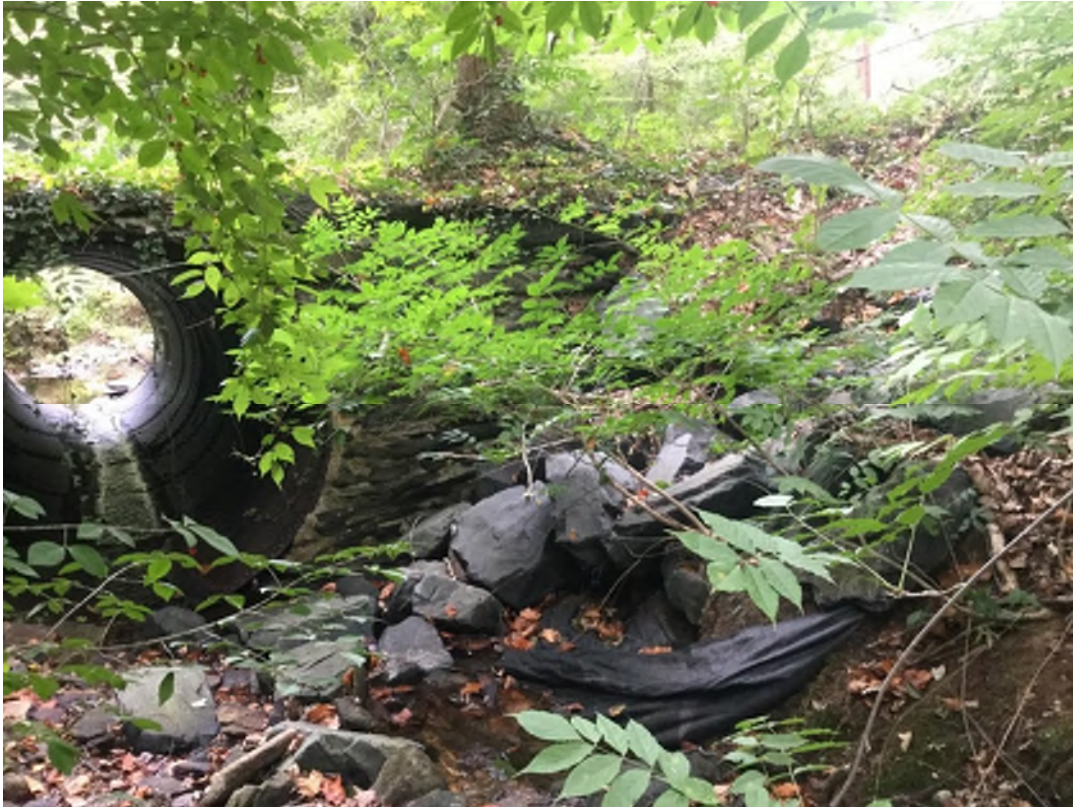
Figure 15: Outfall 26 is an elliptical pipe (24" high by 45" wide) conveying flow to the right bank of the mainstem just upstream of the culvert under Tennessee Drive. Outfall is 20 feet from stream and has 7 feet of riprap outfall protection.

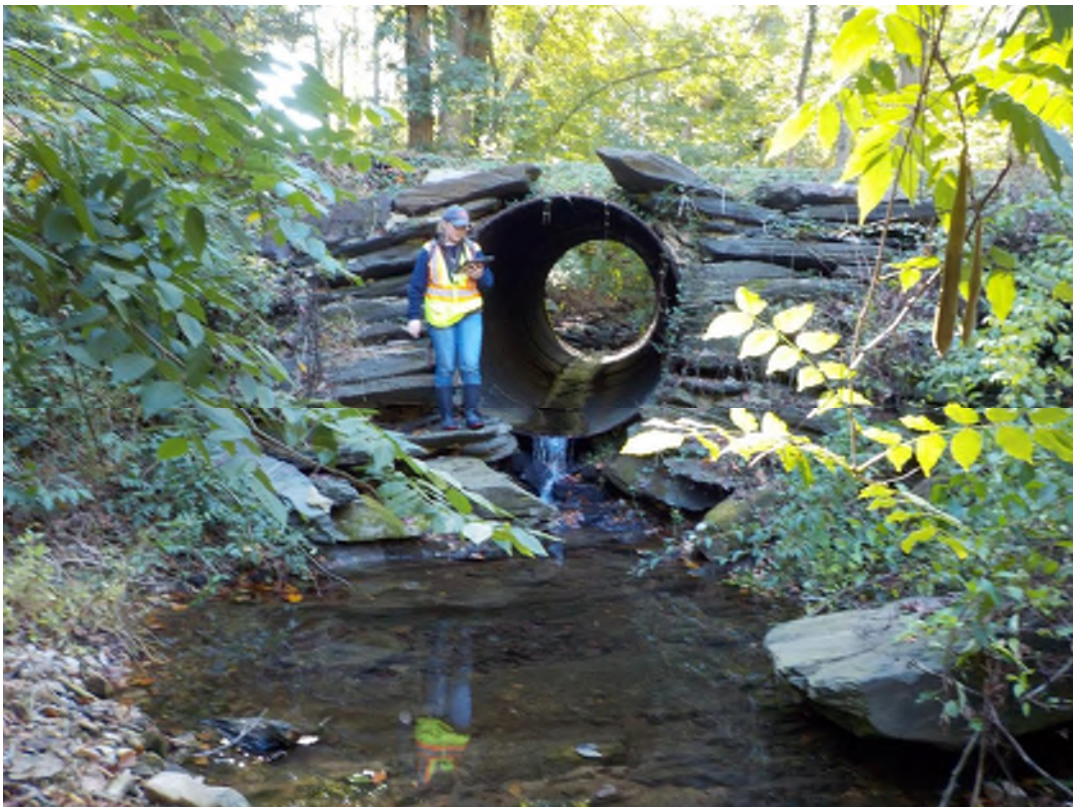
Figure 16: Looking upstream to culvert under Tennessee Drive. Culvert is 78-inch cast iron pipe that is 32 feet long. There is a 2-foot drop to water surface. 10-foot-wide by 12-foot-long scour hole on downstream side.

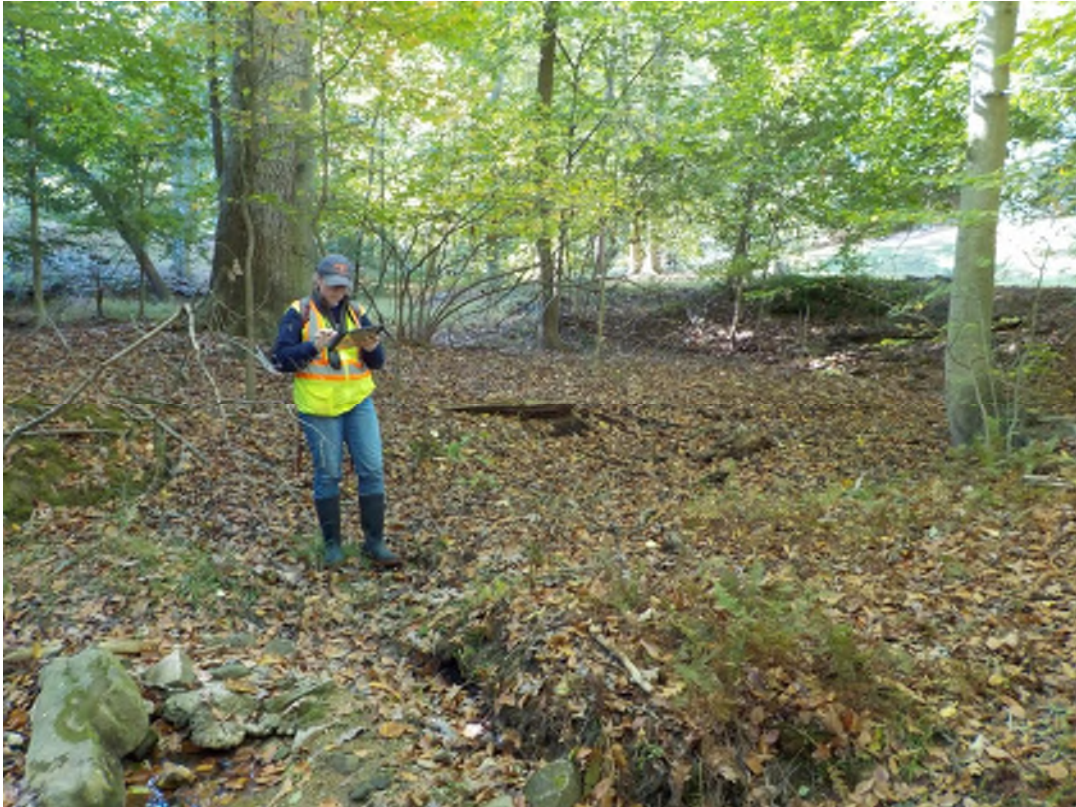
Figure 19: Old oxbow channel on left bank of mainstem.

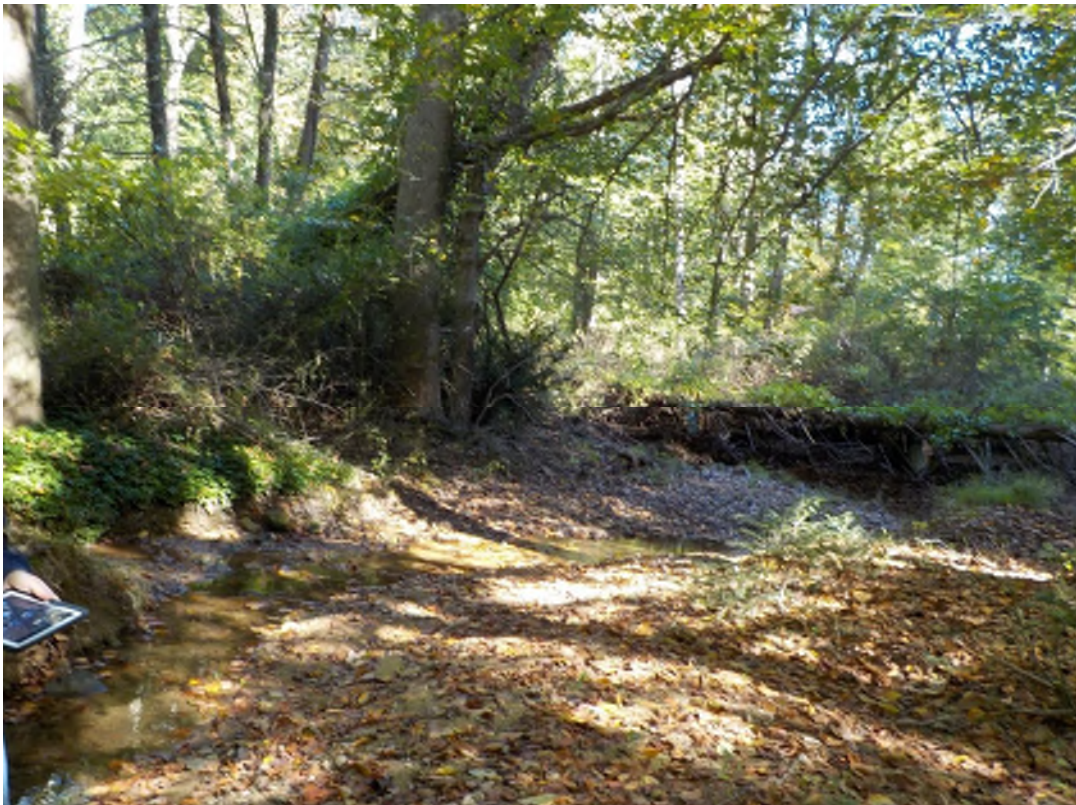
Figure 20: Natural spring enters mainstem on left bank.

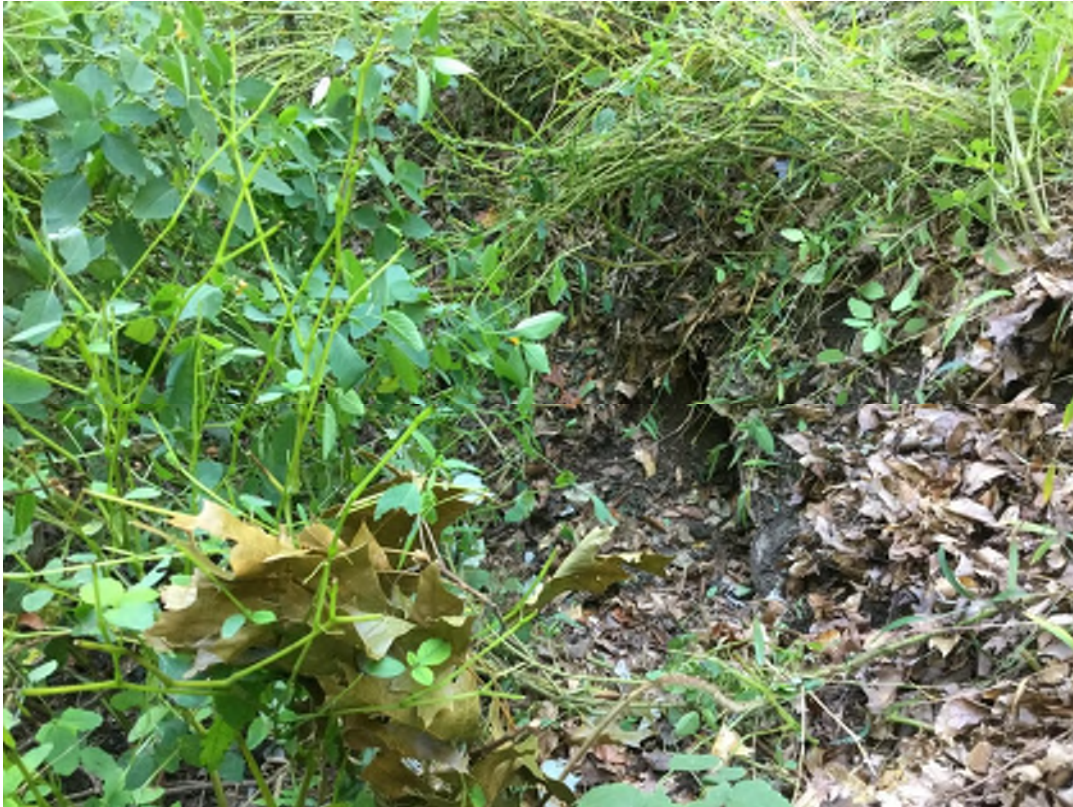
Figure 21: Outfall 29 is a 24-inch concrete pipe that conveys flow to right bank of mainstem upstream of Carolina Avenue culvert. Outfall is 24 feet from stream and does not have outfall protection. Pipe is half full of sediment.

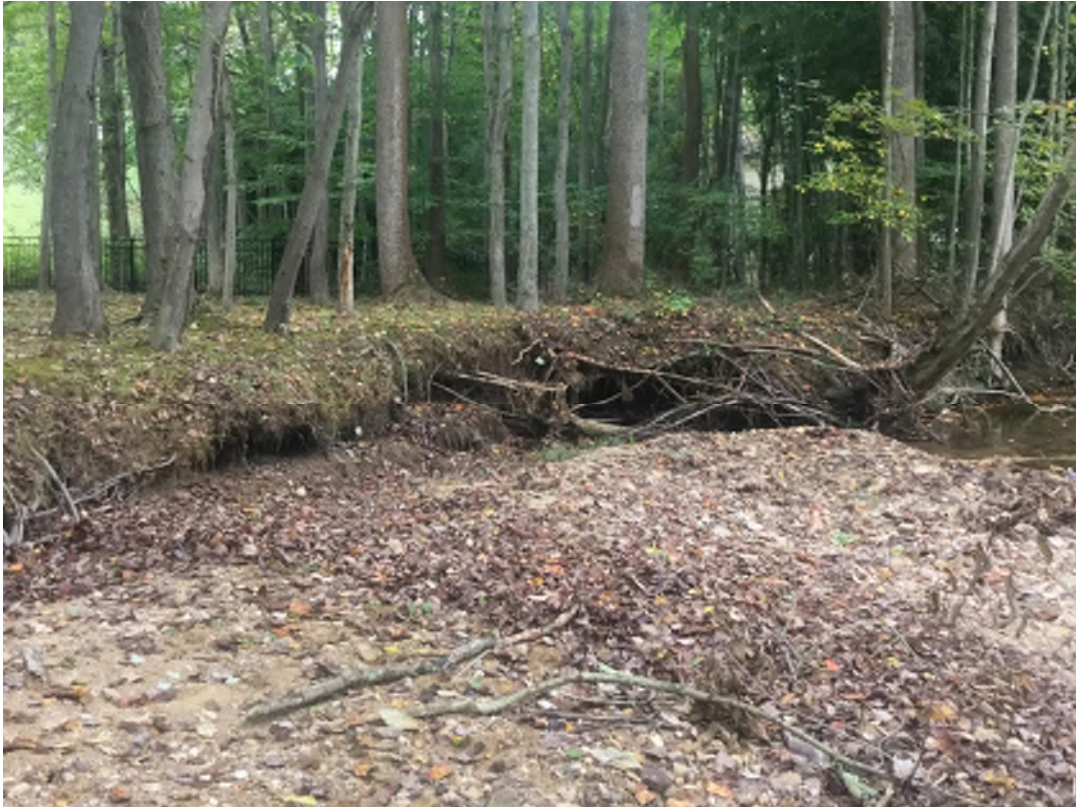
Figure 1: Bank erosion in mainstem.

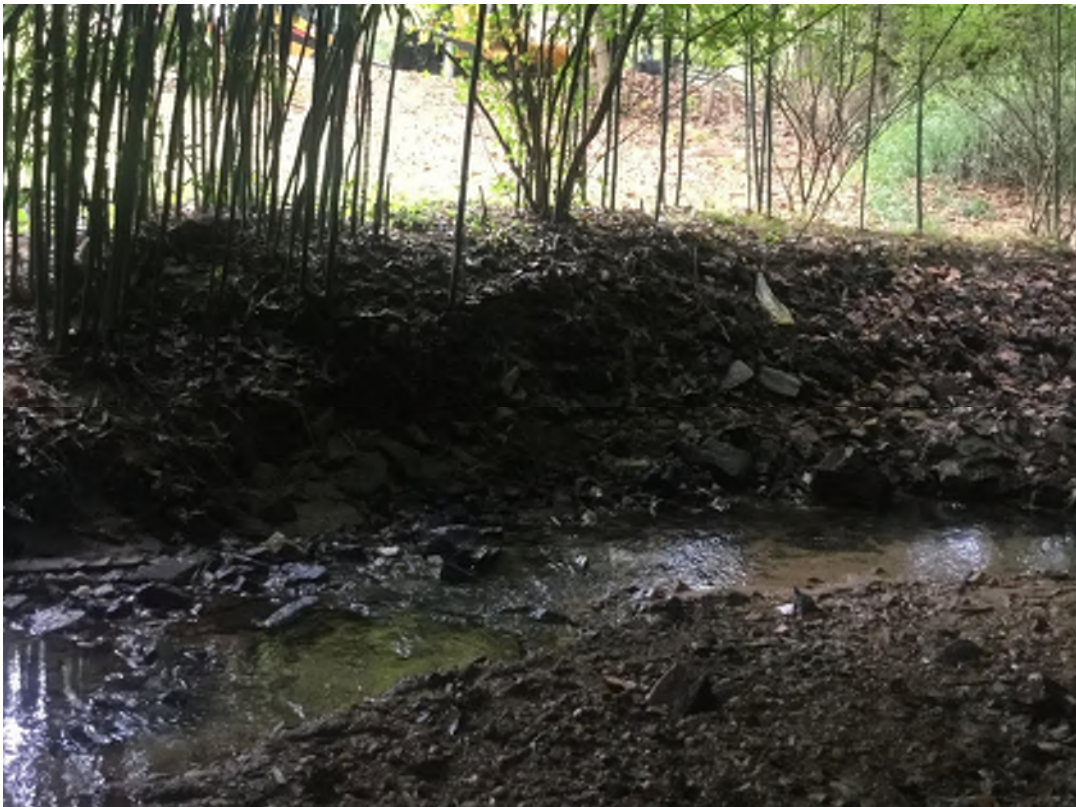
Figure 2: Channel alteration in mainstem. Riprap along left bank.

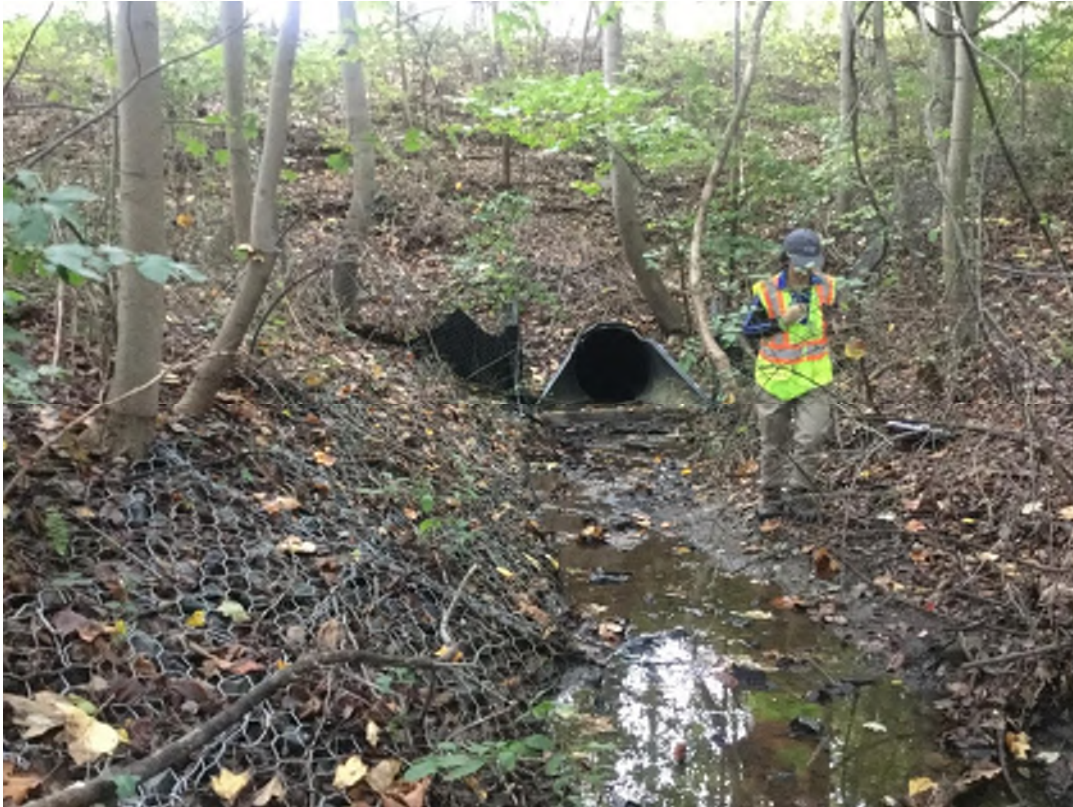
Figure 3: Outfall 40 is a 36-inch plastic pipe at headwaters of tributary 1. Outfall is 44 feet from stream and has riprap outfall protection.

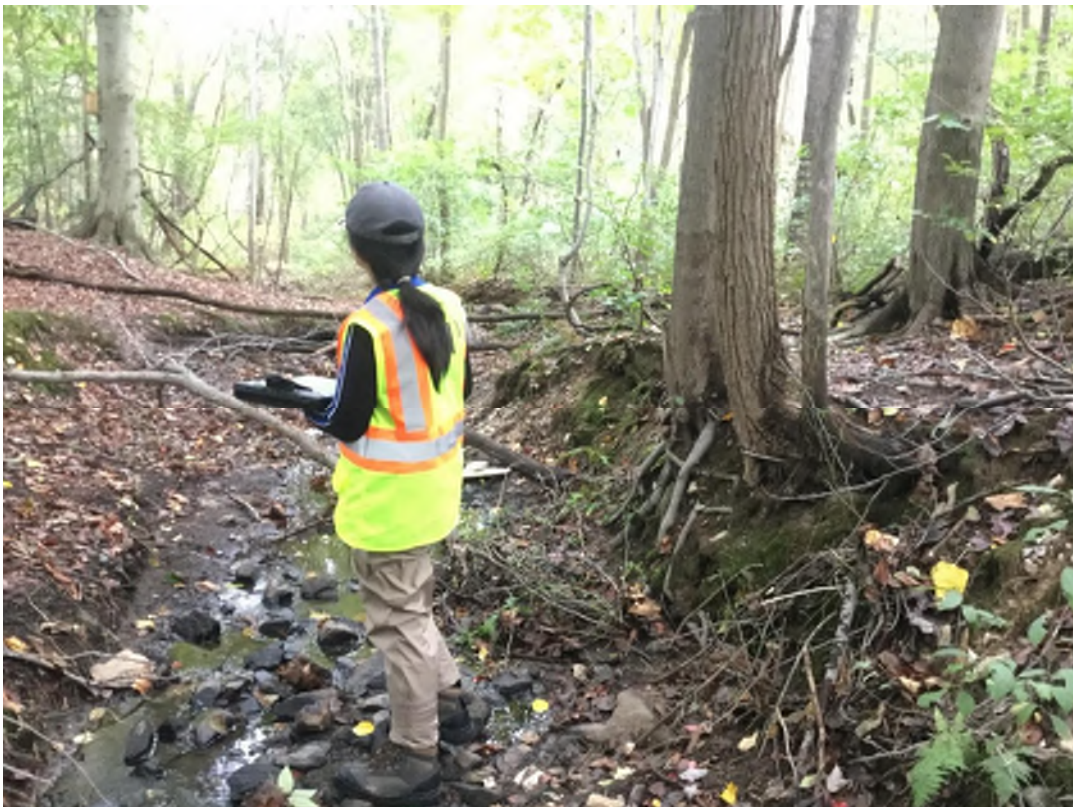
Figure 4: Bank erosion along both banks in tributary 1.

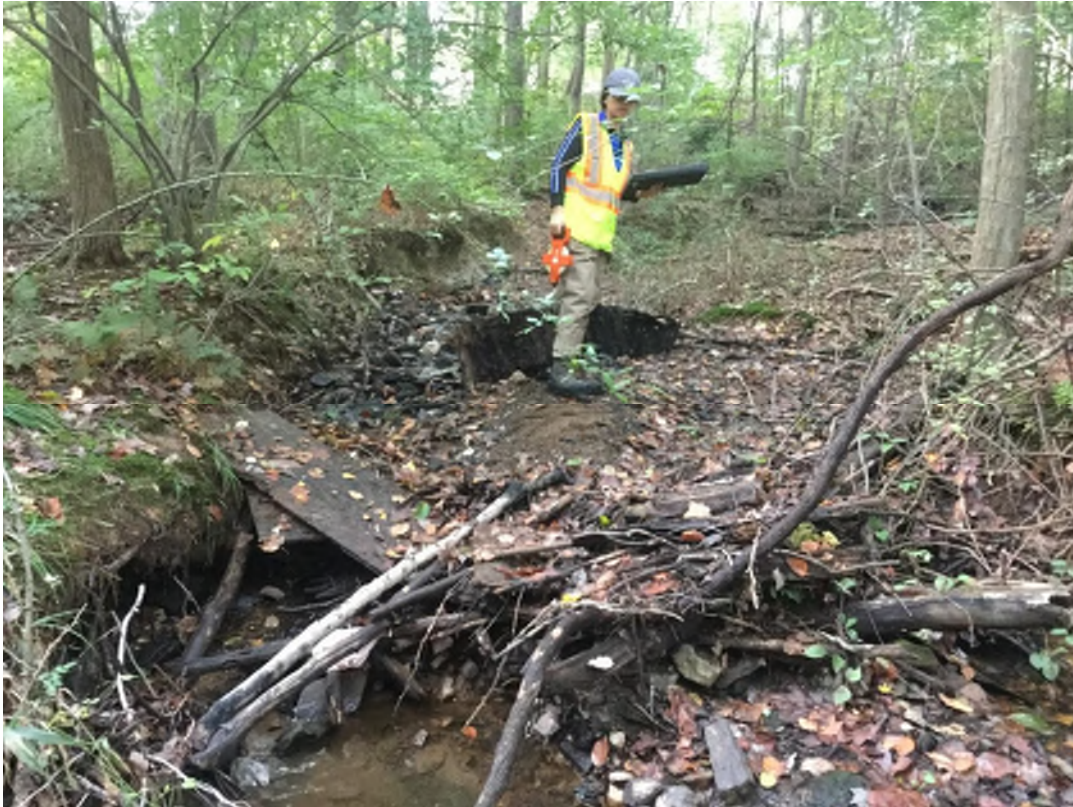
Figure 5: Debris jam in channel of tributary 1. 1.5-foot drop in channel.

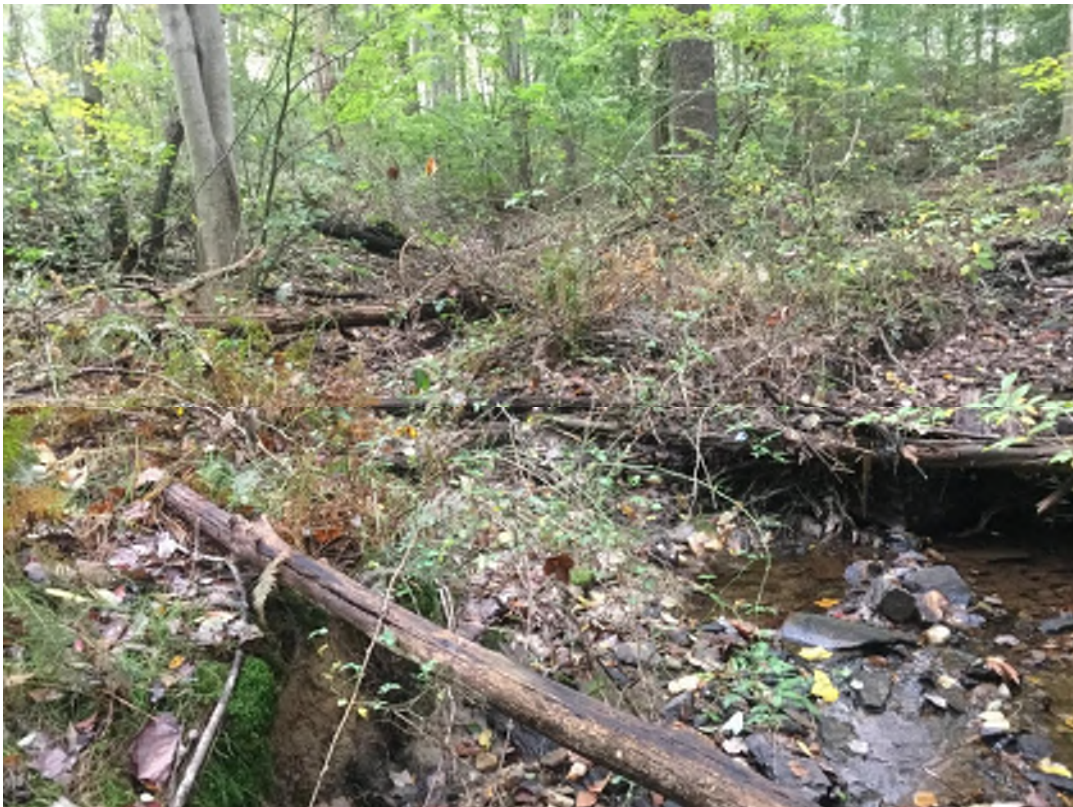
Figure 6: Confluence of dry ditch/depression and stream in tributary 1.
